Building Pipes and Water System Assessment for Habitat Suites Hotel, Austin, TX

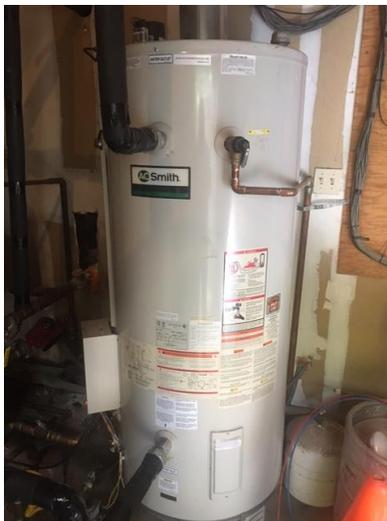
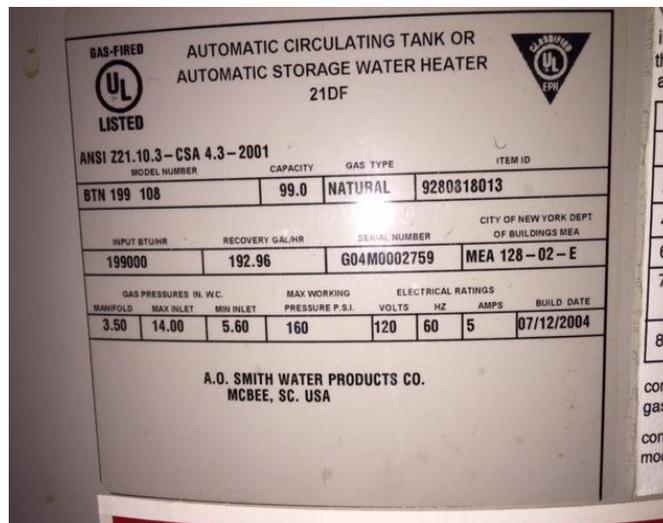
Heater General Specifications (All Equal):

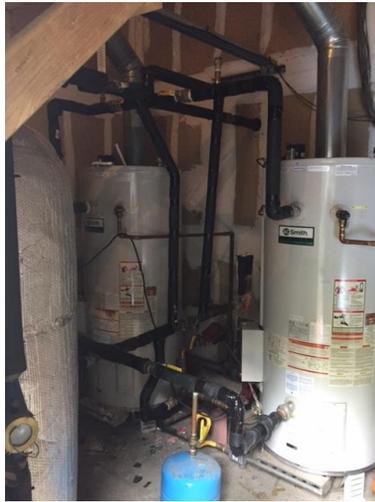
On Site 2 Units per Building with Specs. As Described Below

Per Heater Manufacturer AO Smith specs, the 3 apartment buildings at Habitat Hotel have an adequate design capacity to sustain 64 guests showering (8 minutes max. @ a 2.5 gpm. shower head flow) in each period of two hours and more. Actual mechanical condition, is marginally adequate or not adequate to supply this demand and not apt to compensate for a higher demand load beyond the indicated parameters unless set at 160°F. See sizing documents provided.

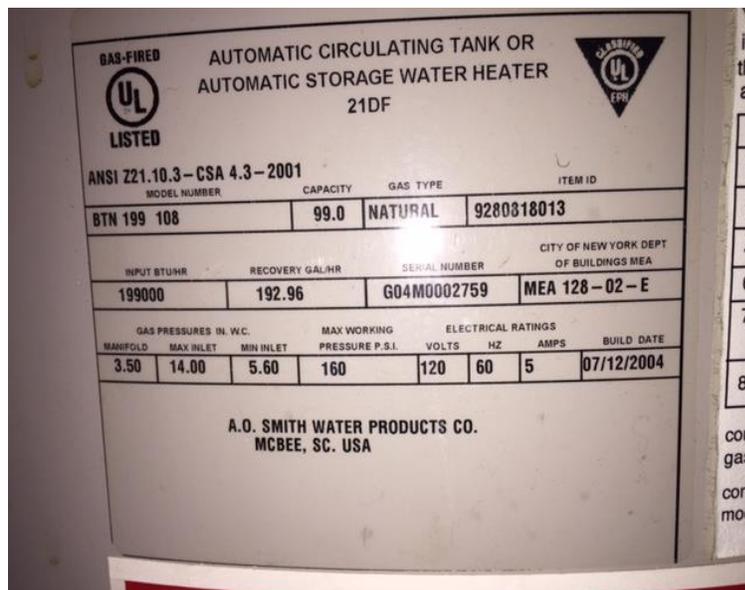
Typical specifications for all heaters

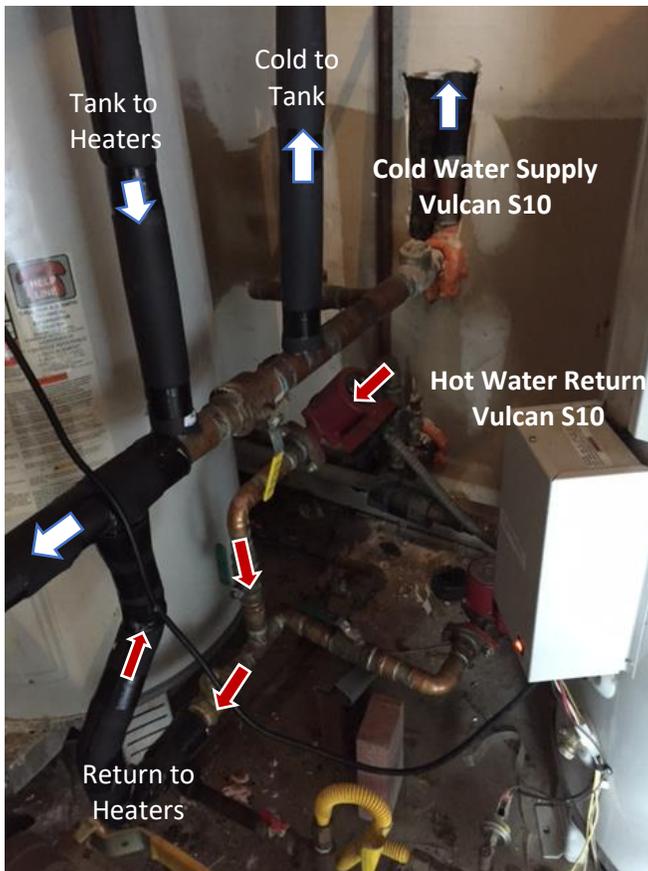
Section 8: Recommended Vulcan Physical Water Treatment Sizes

Cold Water Dia. 1.9" – Vulcan S 10
Hot Water Dia. 1.7"– Vulcan S 10

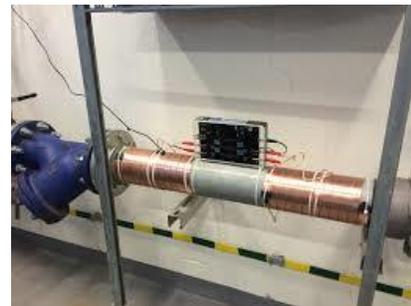
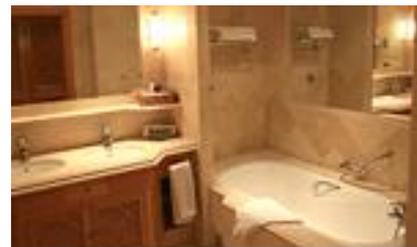
Installation at Pfizer Puerto Rico Operations
 Chilled Water Loop Vulcan S100

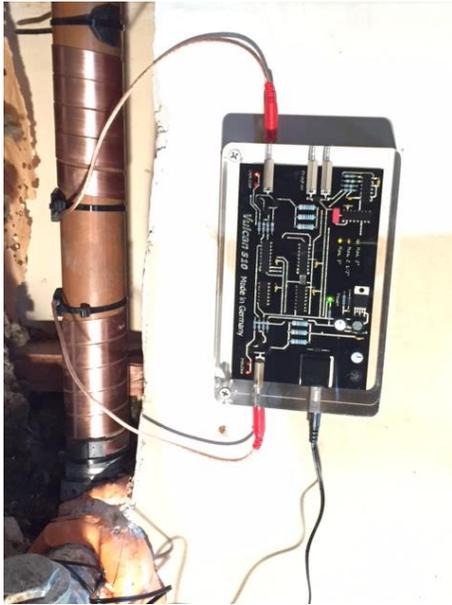
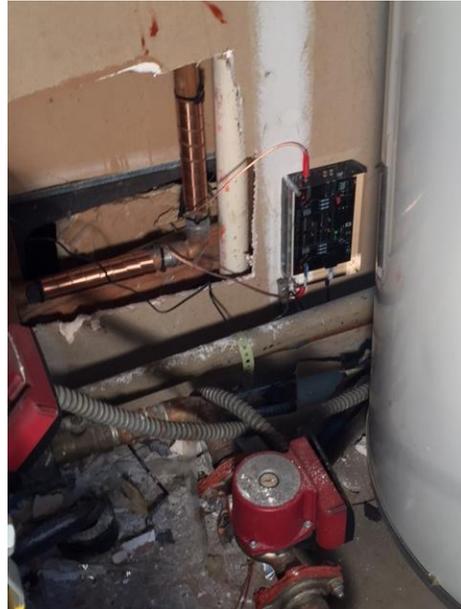
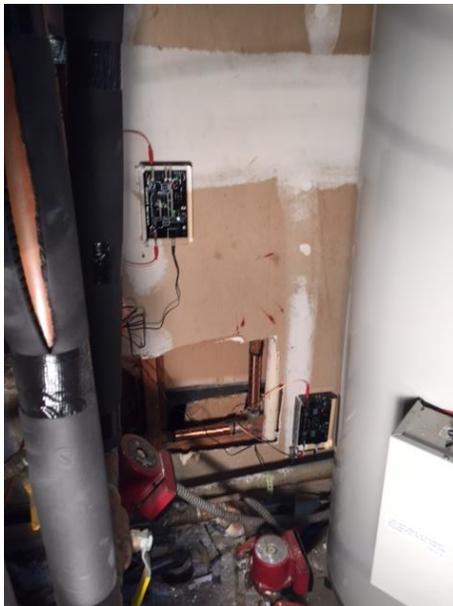
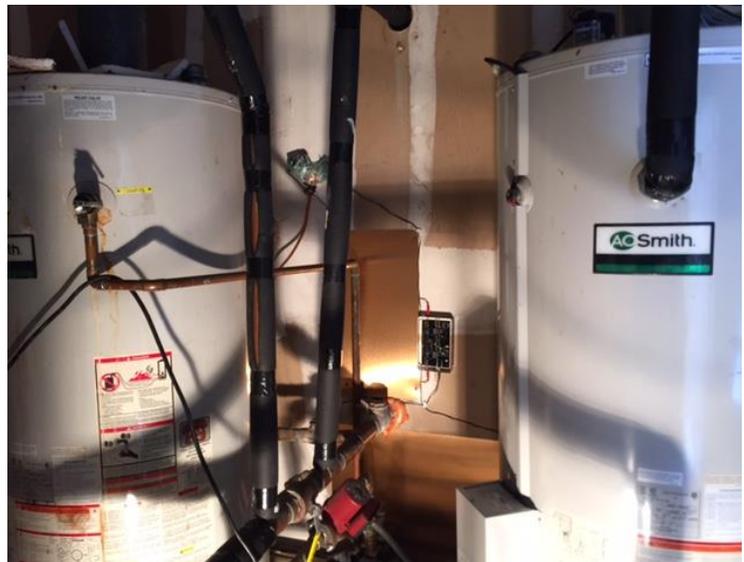
Actual Installation Pictures at Habitat Suites Vulcan S10 (2 Units) Cold Main and Hot Water Recirculation Loop

2 aluminum inspection panels were manufactured to cover the gaps in the wall.
