## Installation details

### The Be'er Sheva Grand Mall

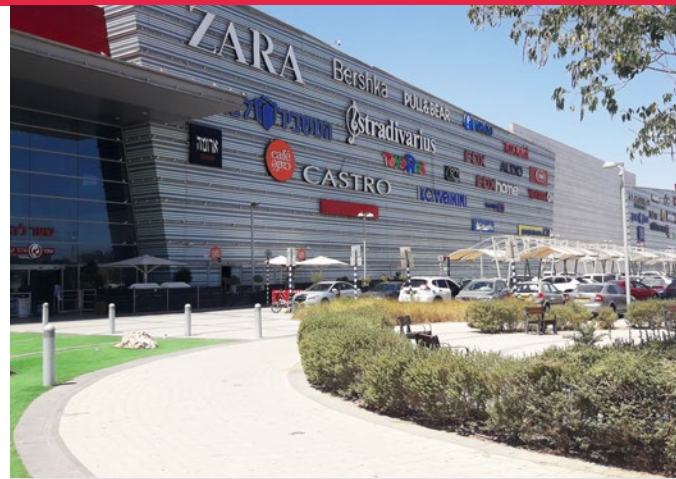
- Location:** The Be'er Sheva Grand Mall, Israel  
myofer.co.il
- Model/area:** **Vulcan** S250 x 4 units for 4 cooling towers
- Problem:** Each cooling tower has 2 heat exchangers.  
The difference in pressure increased between the inlet and outlet of the heat exchanger, which showed a developing blockage.  
The heat exchangers had lost in work capacity every month due to the multiplicity of scale and rust.
- Result:** 5 months after installation, there are no scale issues in any cooling tower heat exchanger systems.  
Due to the excellent results, more Vulcan will be installed for the rest of the company's facilities in Israel.
- Installed by:** EYE-IN ELECTRONICS

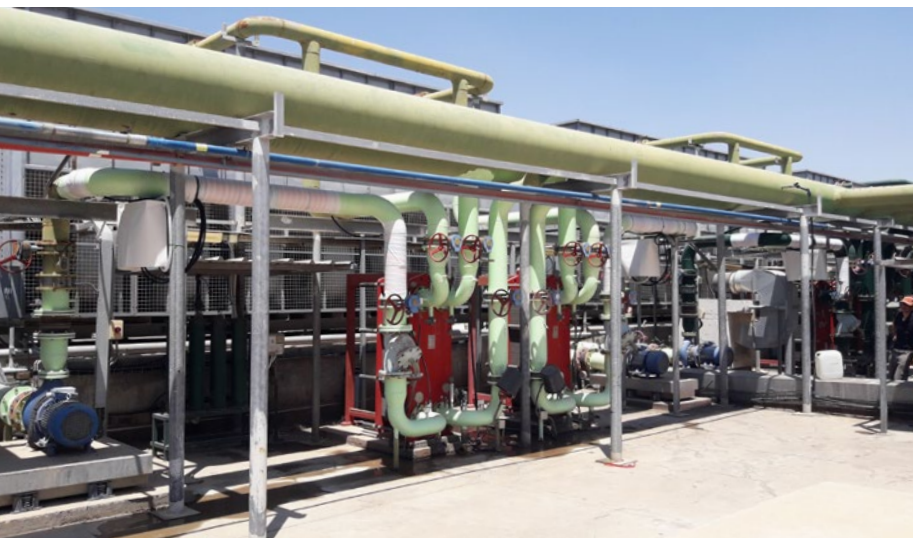
Vulcan S250 outdoor installation: on the roof, with the sun most of the year. The temperature at this time was 38 - 40 °C. In winter, it is rainy and the roof should be sealed to IP-68. Vulcan impulse bands were well wrapped and the Vulcan unit was in the outdoor box.
