## Installation details

Location: Lhasa 21 Inn, Tibet  
 Model:

Vulcan 5000  
 Area: Water main  
 Installed by: Shaanxi Wasser

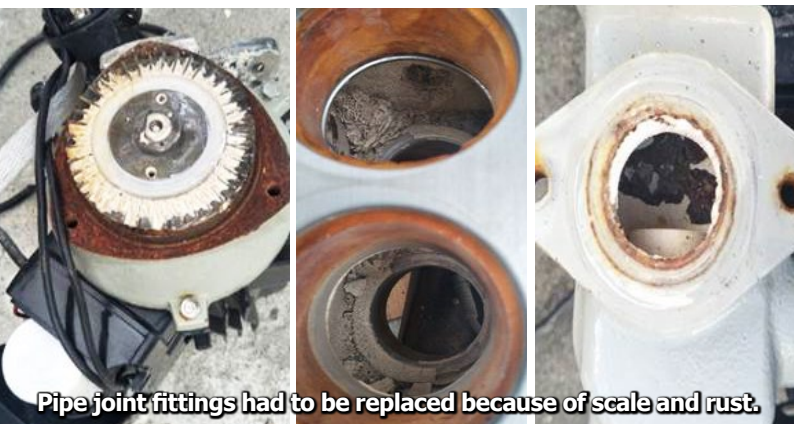
Pipe joint fittings had to be replaced because of scale and rust.

In April 2017, a 6-ton tubular solar water heating system was installed. Without any water treatment, as of May 2018, due to the serious scaling problems, manual descaling and system maintenance had been made for 3 times. Even solar glass tubes, headers, valves, pumps, etc. must be replaced, the client had a large loss.

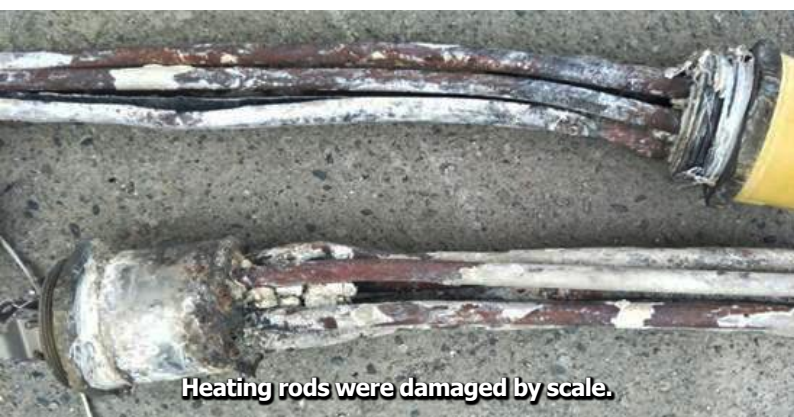
Heating rods were damaged by scale.

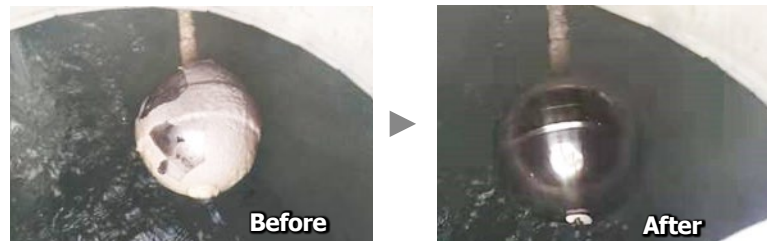
2. The scales on the float valve in the hot water tank have been softened, they can easily be tapped off.
