## Installation details

## Vulcan effect in the factory - before and after

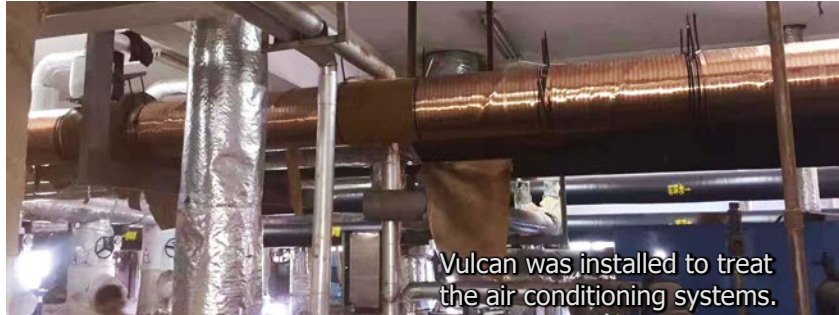
Vulcan was installed to treat the air conditioning systems.

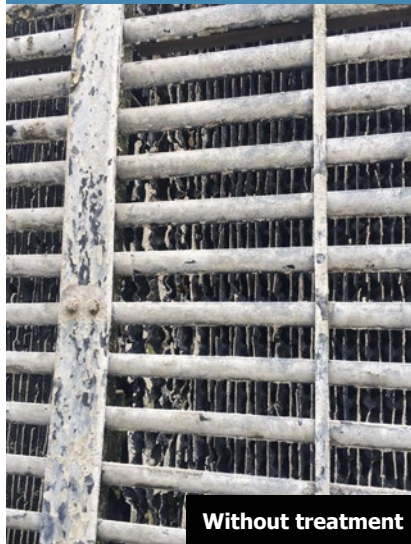
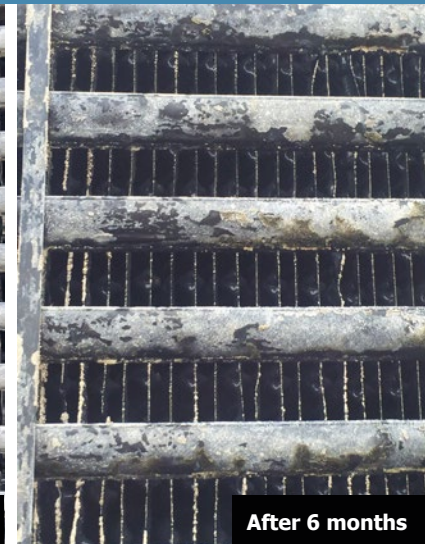
Cooling tower fills: the silica ( $\text{SiO}_2$ ) which was usually accumulated in the fins has disappeared; the energy consumption of the air conditioning systems and the cleaning effort have been reduced.

Without treatment

After 6 months

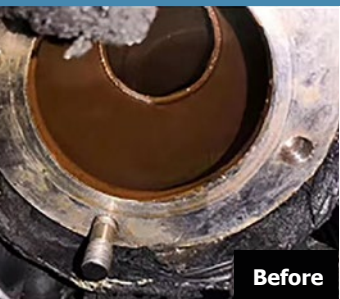
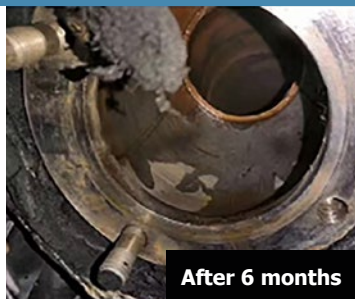
### Pump

Before

After 6 months

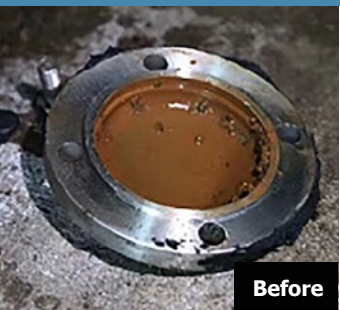
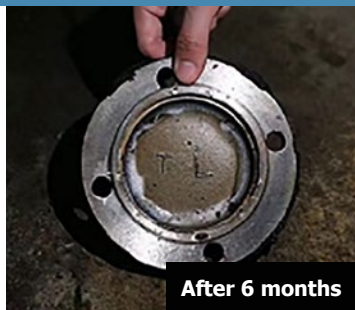
### Valve

Before

After 6 months

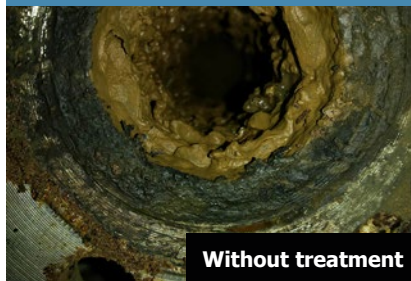
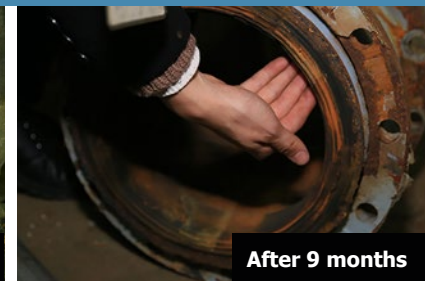
Cooling tower valve: large amount of sludge and scale have been gradually reduced.

Without treatment

After 9 months

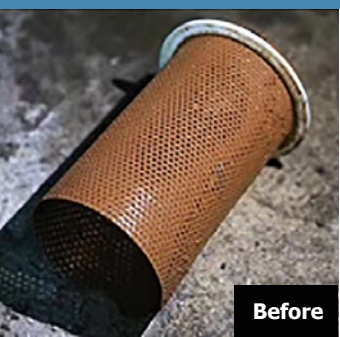
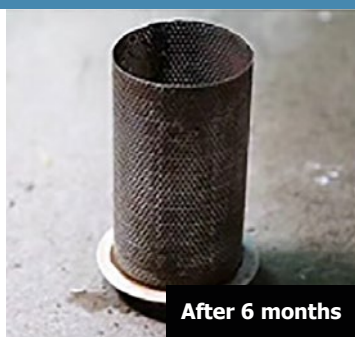
### Filter

Before

After 6 months
