The Cooling System in the Poultry Farm

Installation details

Location: 3 chicken farms in Morocco

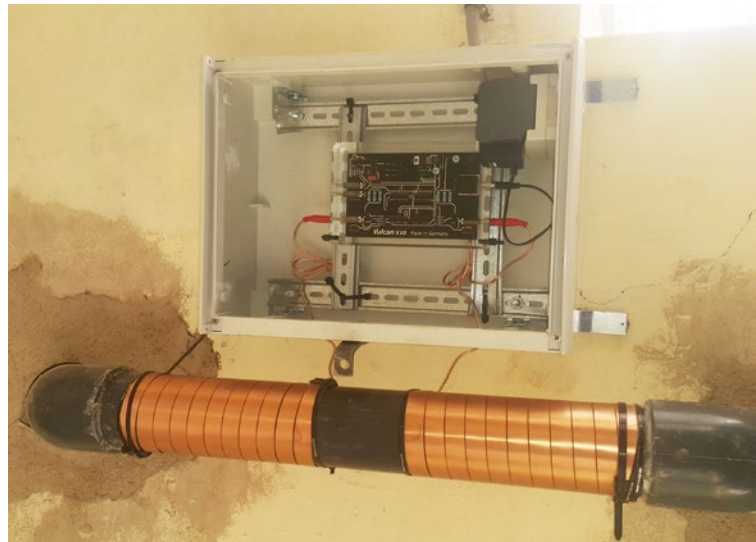
Vulcan S10 was installed in the water main to treat 6 cooling systems in 3 chicken farms.

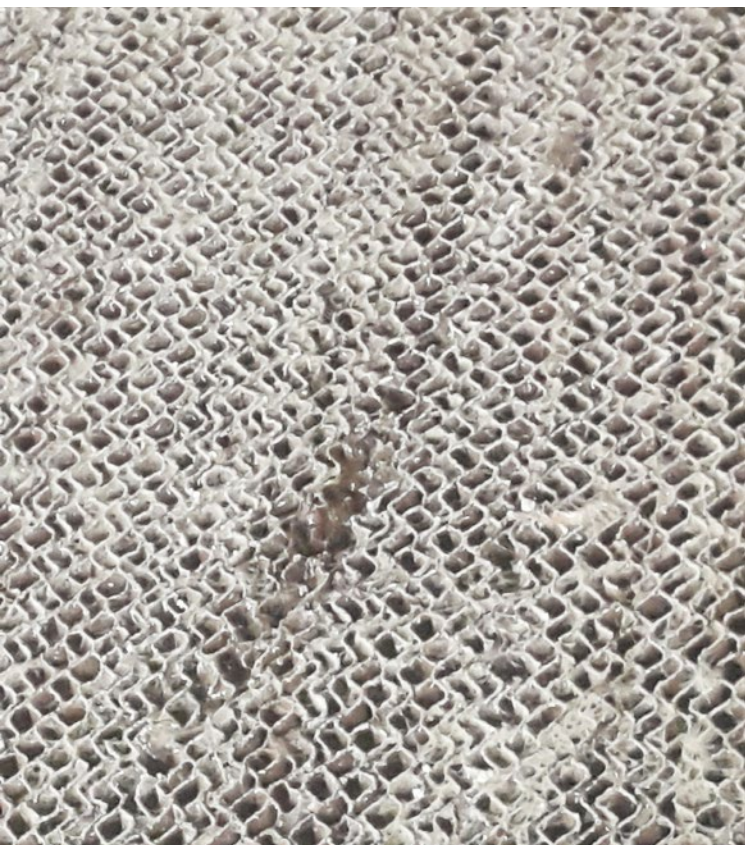
Without any water treatment, scale was hard like stones.

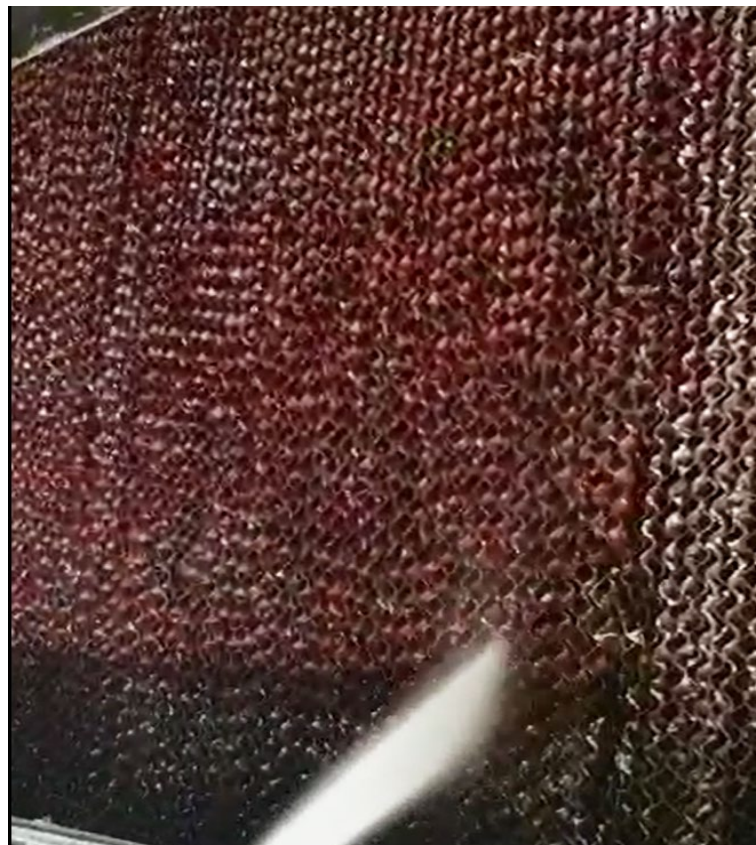
After Vulcan S10 had been installed for 2 weeks, scale had been softer and easily removed with a water gun.

Result: After Vulcan S10 had been installed for 2 weeks, scale had been softer and easily removed with a water gun.
